# EVALUATION OF OCCUPANT PROTECTION IN BUSES

TP 14006E

Prepared by: RONA Kinetics and Associates Ltd., North Vancouver, B.C.  
Report RK02-06, 4 June 2002

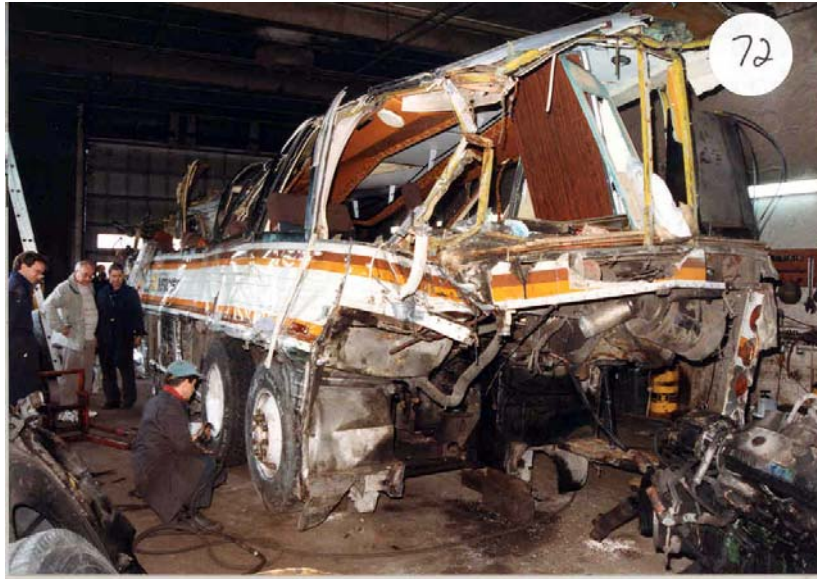
*Comments:* The driver was pinned in the bus and sustained fatal chest injuries from the steering wheel. Of the 43 passenger fatalities, 42 died on impact, one died a few weeks later. All fatalities sustained multiple injuries. The main cause of the injuries was the major damage to the bus when it struck the ground after falling down the ravine. The front of the bus collapsed up to the front axle and there was major deformation at the front left corner. The driver's space and first three rows were compressed rearwards. The seats in rows 5 and back were deformed, however most remained anchored to the floor. The seat backs had been loaded by the occupants. The main contributory factor to the collision was the poor mechanical state of the brakes. The air brake system was only at 30% efficiency and the regular brakes were of no use and when the driver attempted to downshift, the transmission went into neutral. In the coroner's report there were 23 recommendations all of which related to collision prevention including road, vehicle and driver factors. There were no recommendations for improved bus occupant protection during a crash.

Figure 1: Case 1 - Left Rear View of Bus Showing Major Deformation

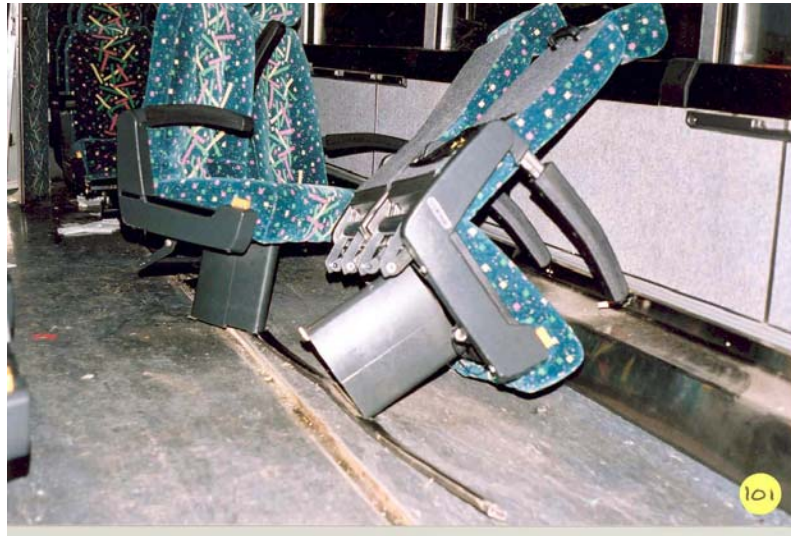
Figure 2: Case 4 - Example of Seat Detachment

Consideration of a standard such as ECE 80 or ADR 68 which address seat securement and occupant loading is recommended.

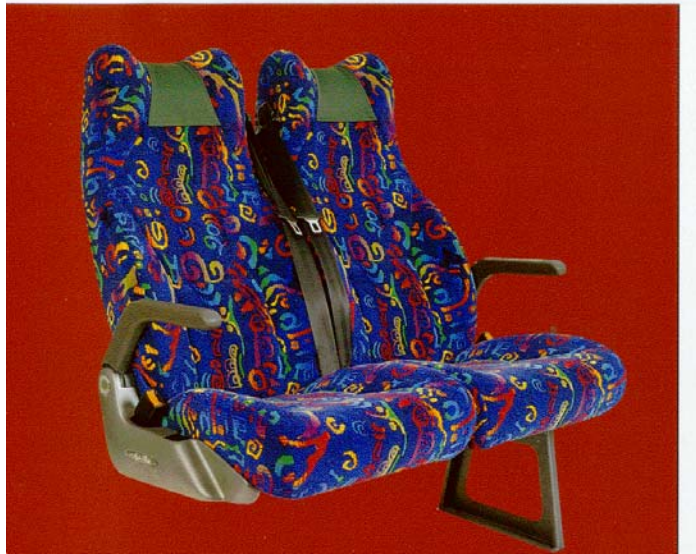
Several specialist seat manufacturers supply the bus manufacturers. The main supplier of seats for use in motor coaches is StyleRide. They make a variety of seat units for use in the different types of buses and coaches. All the seat models are made to comply with the requirements of the appropriate regulations, including Australian Design Rule (ADR) 68, Occupant Protection in Buses. A typical ADR 68 compliant StyleRide coach seat fitted with lap/torso belt systems is shown in Figure 4. The seat system has a single inner leg and is bolted to the bus structure on the outer side. The main supplier of the belt restraint systems fitted to the seats is Autoliv Australia P/L. The belts are now universally lap/torso.

Figure 4: ADR 68 Compliant StyleRide Bus Seat

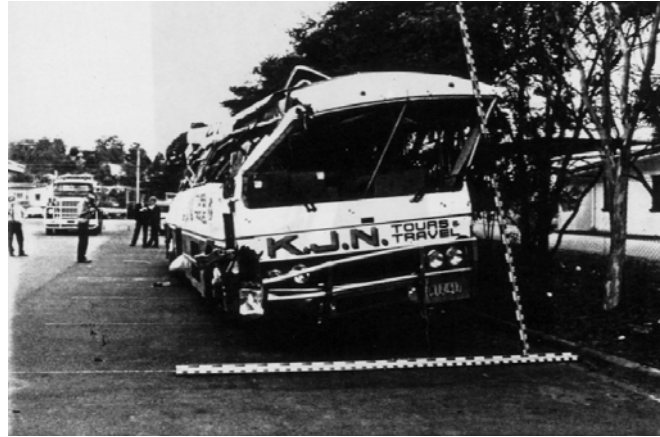
| <i>Comment:</i> | The injuries resulted from ejection (6 people, including the driver) and contacts with the interior of the coach from the initial deceleration and the rollover (Duignan, 1990). The windows of the coach were toughened glass. Examination of the coach showed that 19 of the 22 seats suffered fractures to the anchorage points. The coach structure also dynamically deformed approximately 30-35 degrees to the side during the rollover, reducing the available occupant survival space. |

Figure 5: Front of the Bus in Case 4 Showing Deformation

In both rollover collisions (Cases 4 and 5) the coach structure was considered by the authors to have performed poorly. In the Mt Tamborine collision (Case 4) the dynamic deflection of the structure above floor level was estimated to be approximately 35 degrees. This was compared to the (then) new Australian Design Rule ADR 59 requirements by the authors, where the structure is not to deform more than approximately 11 degrees. This requirement is shown in Figure 6. In the Talbingo collision (Case 5) the entire roof structure was torn off to the level of the base of the windows leaving the interior of the coach exposed and offering no protection to the occupants.

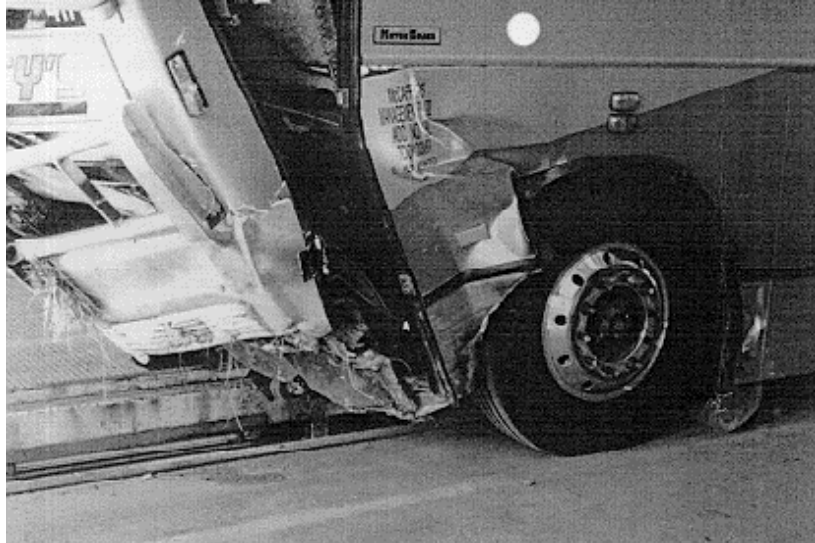
*Description:* The fully occupied 52 seat coach (built in 1996) was travelling at 85 km/h (from the tachograph), when it impacted a culvert causing significant damage to the lower front of the coach. Approximately one metre of crush occurred to the lower front, equivalent to a 6g deceleration, the vehicle coming to rest with its rear just past the culvert.

Figure 8: Front of the Bus in Case 6 Showing Deformation - Side View
